# Manhole Inspection Summary

Manhole # S15AA1016MH

**Location** Address: **REAR 3702 PARK HEIGHTS AVE**

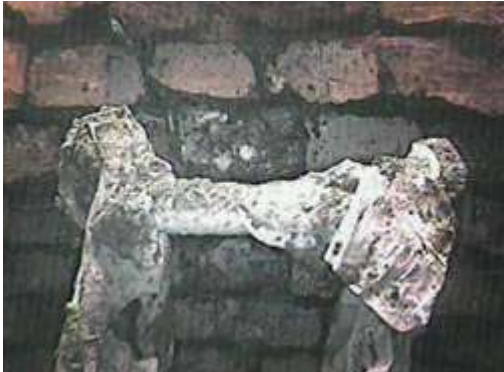
Defect 1

☒ **Evidence Of Surcharge** Depth: **6** (ft.) ☐ Active Surcharge Present

EVIDENCE OF SURCHARGE

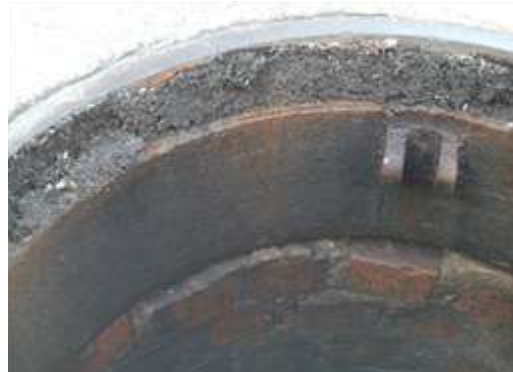
Defect 2

Condition: ☐ Sound ☒ **Cracked** ☐ Leaks

CRACKED FRAME

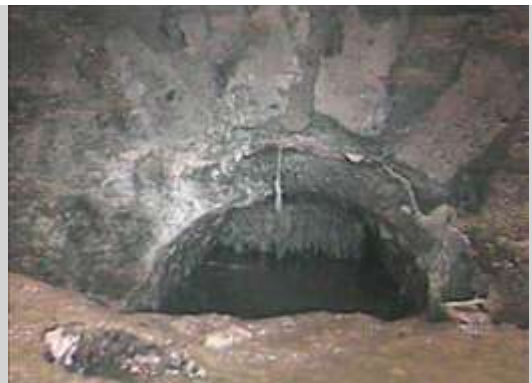
12 O'Clock Outflow

8 in. Circular Gravity Sewer  
Pipe Out @ 12 O'Clock

Deposits: ☐ None ☐ Mud ☒ **Gravy** ☒ **Debris** ☒ **Grease**

Silt Depth: **4** (in.) Deposits Extent: **Heavy**
